## **SERVICE BULLETIN 14-01-31**

**Subject:** Cracking near the bend in horizontal stabilizer front spar.

**Affected Models:** All RV-6/6A,7/7A,8/8A Flying or under construction

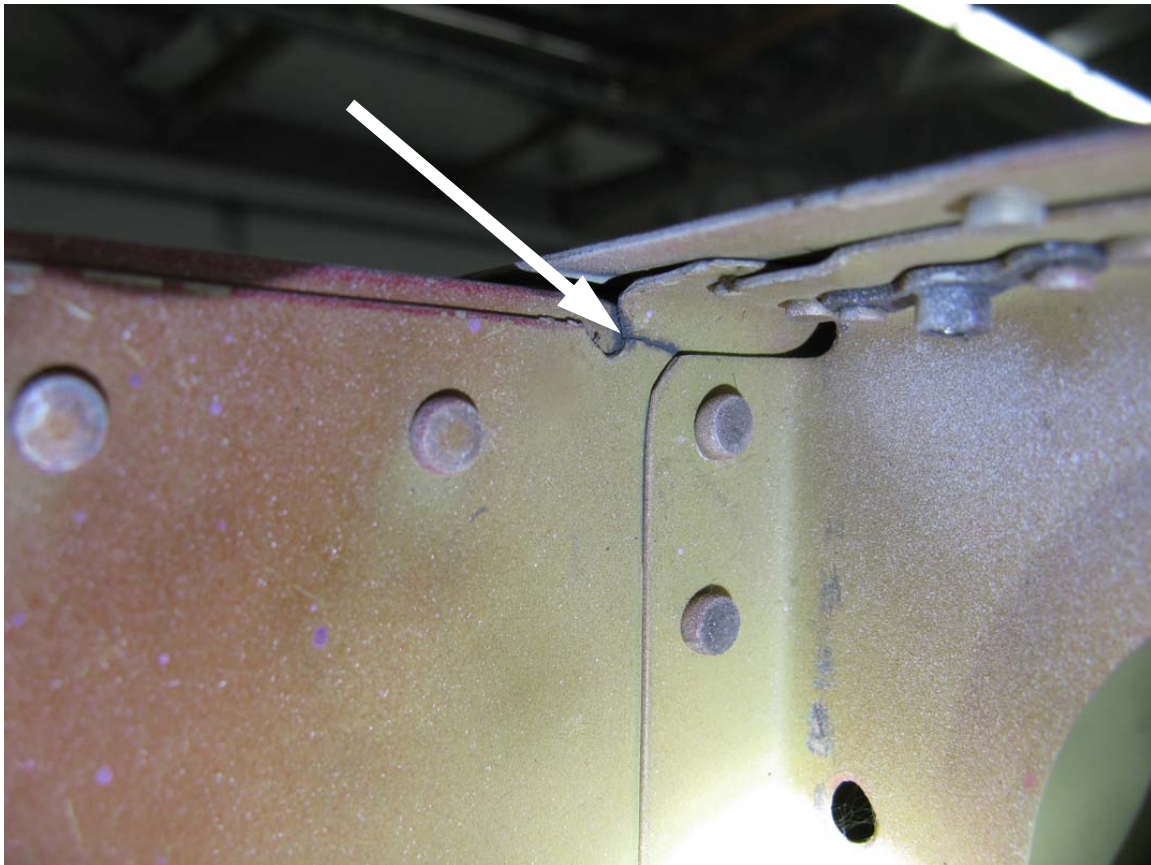
Cracks in the forward spar of the horizontal stabilizer have been found emanating from the stress relief notch at the inboard end of the spar flanges. See Figure 1 and remaining figures in this bulletin.

**FIGURE 1:** Typical crack in horizontal front spar web emanating from relief notch.

Inspection: Remove the Empennage fairing. Carefully inspect for cracks emanating from the stress relief notch at the inboard end of the forward horizontal stabilizer spar flanges. (see Figure 1 and figure 3). Clean the area and remove any paint, overspray or primer that could hide a crack. Cracks may be very small and hard to detect.

Inspect for cracks as described. If cracks are present, stop drill cracks and install HS-00001 Doubler (RV-6,7) or HS-00003 Doubler (RV-8) and HS-00002 Rib Flange Angle (RV-6,7) or HS-00004 Rib Flange Angle (RV-8) to both sides of the aircraft before further flight.

If cracks are 1/8 inch or shorter use a file to increase the size of the stress relief notch enough to remove the crack. File past the visible end of the crack 1/16 inch. Blend the shape of the filed away area by increasing the overall size of the relief notch.

If cracks are longer than 1/8 inch stop drill the crack using a #40 drill bit and then deburr.

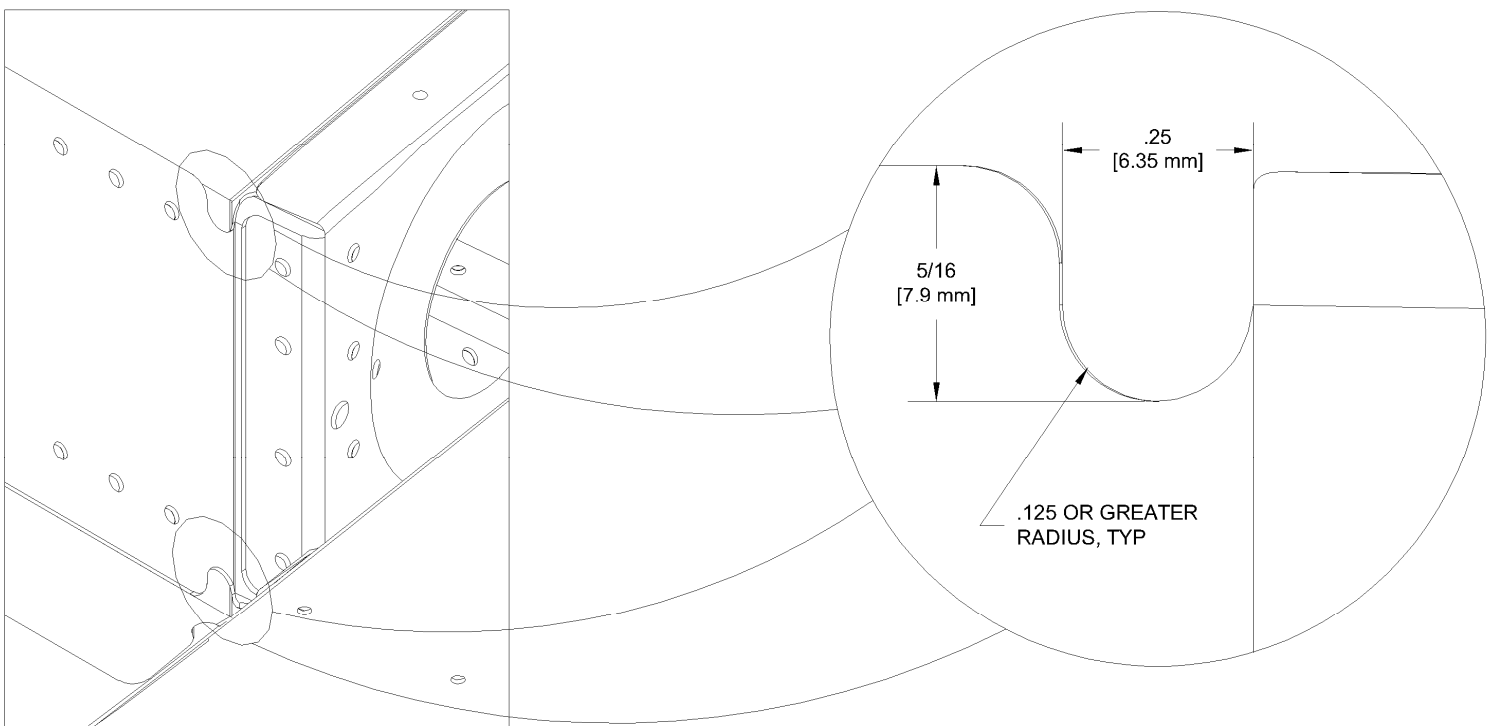
**FIGURE 3: RELIEF NOTCHES**

**Step 8:** Inspect the corners at the inboard end of the top and bottom fwd spar flanges on the left and right spar halves for the presence of relief notches as depicted in Figure 3.

If notches are not present, use a round file to add relief notches (first refer to the following step... adding a missing notch may be done in conjunction with removing a crack). This will require trimming the skin slightly as shown in Figure 2 to gain access for the file.
